SCREENING SITE INSPECTION REPORT
FOR

MAPCO GAS PRODUCTS, INC.
aka THERMOGAS COMPANY

ATHENS, ILLINOIS

JUNE 14, 1990

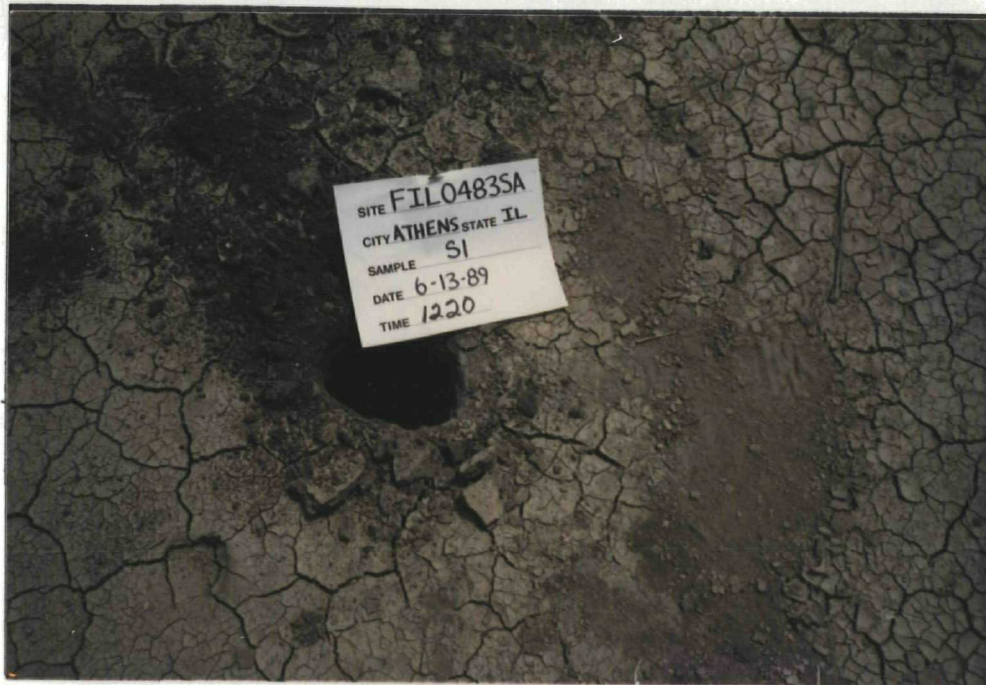
DESCRIPTION: Close up of soil Sample SI

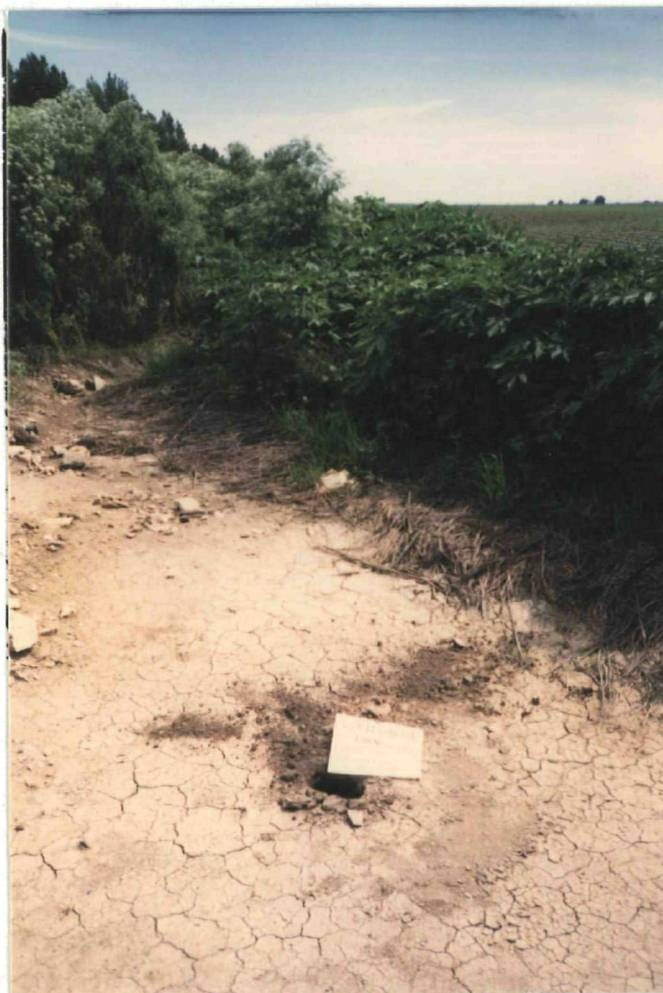
DIRECTION OF
PHOTOGRAPH: SouthWEATHER
CONDITIONS: SUNNY, 65° F.PHOTOGRAPHED BY: Ronnie GalmoreSAMPLE ID
(if applicable): SIDESCRIPTION: Soil Sample SIis locate near a farm
field where lagoan's water
is pumped. Perspective of
SI.

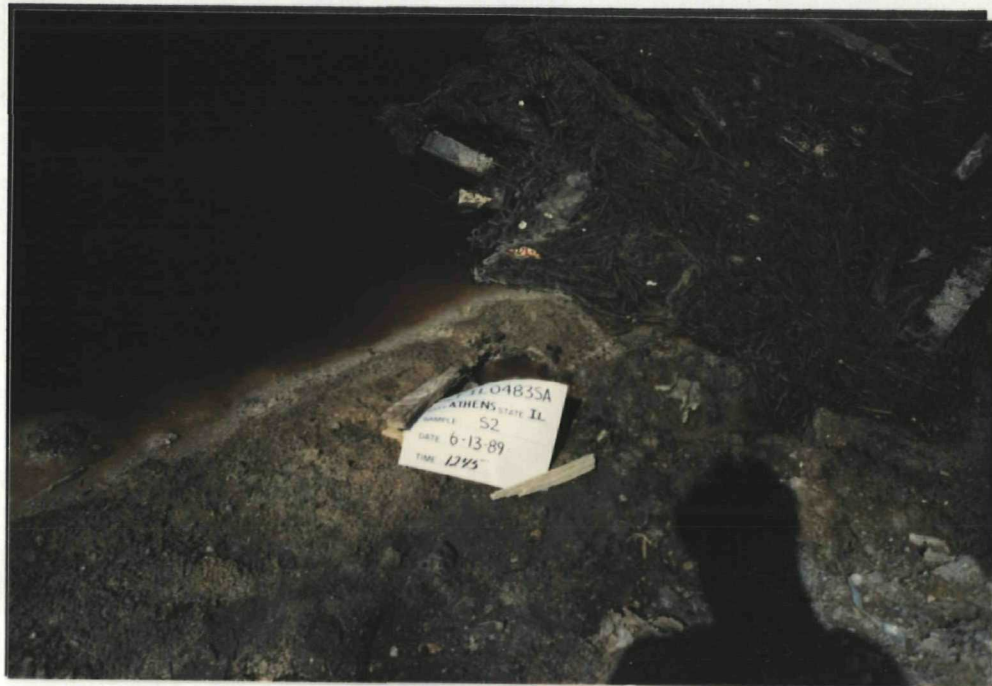
DESCRIPTION: Close up of Soil Sample S2

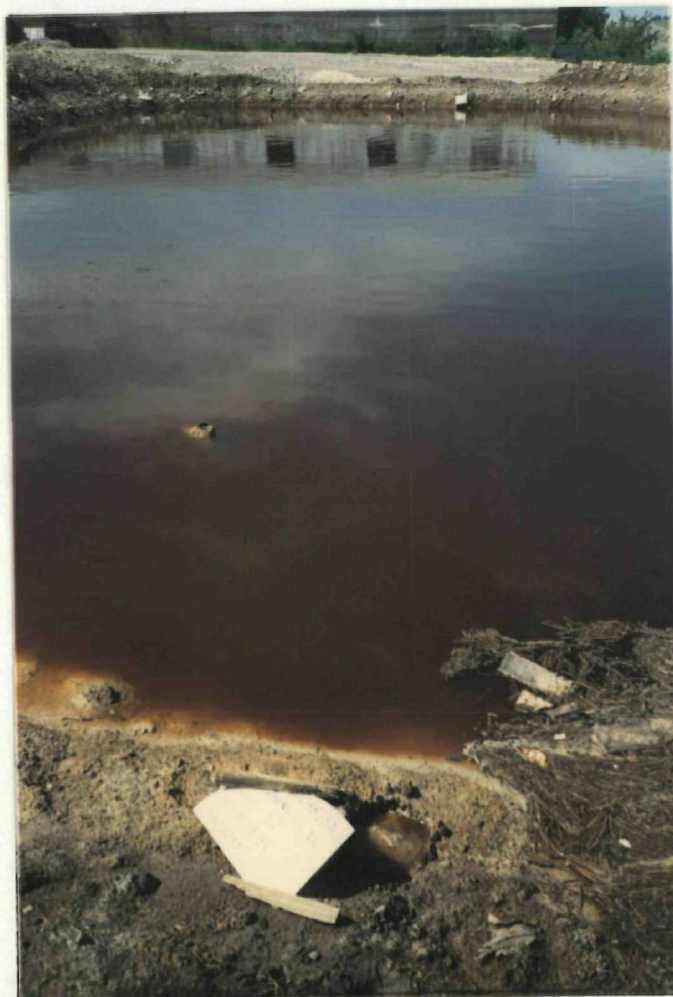
SAMPLE ID
(if applicable): S2 is located

DESCRIPTION: at the edge
of the lagoon. The sample
was taken from the south end
of the one site lagoon.

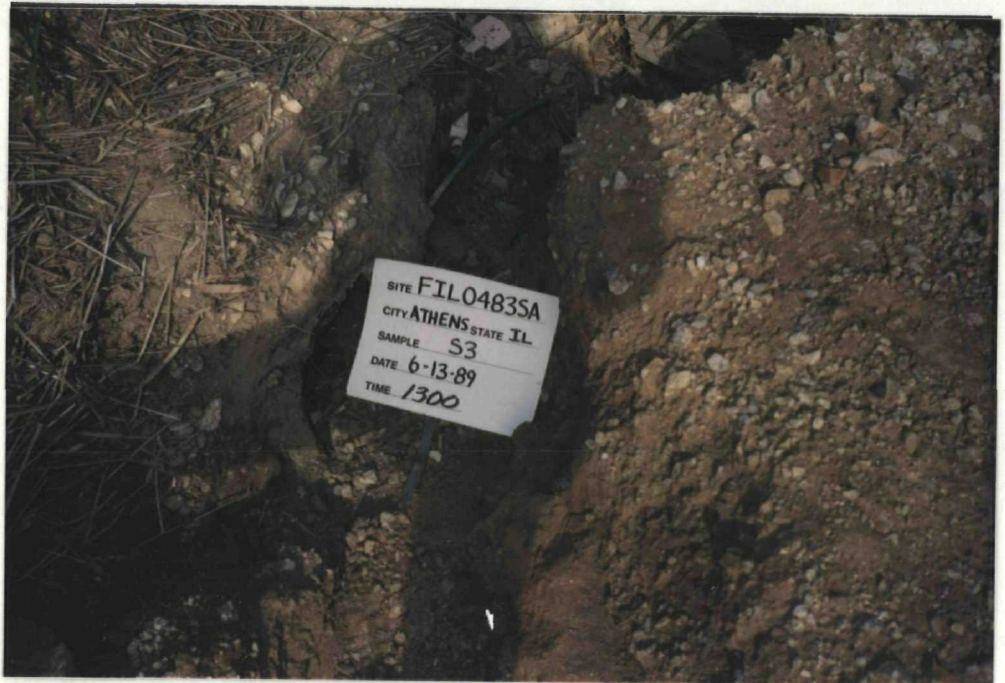
DESCRIPTION: Close up of soil Sample S3

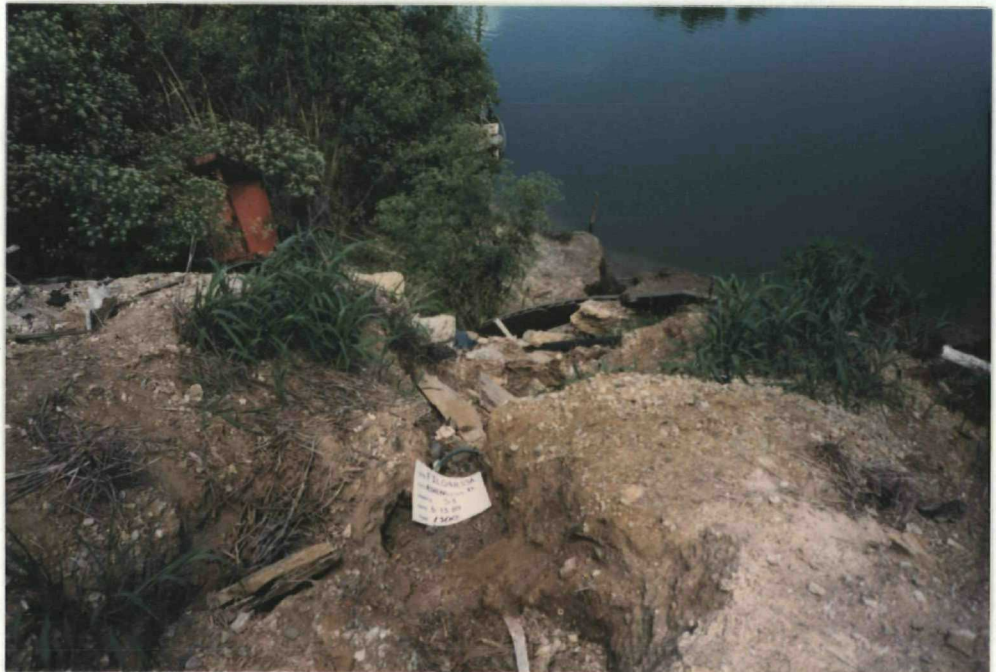
DESCRIPTION: Soil Sample S3 was collected from a runoff channel located behind the dry pesticide building that leads to the quarry.

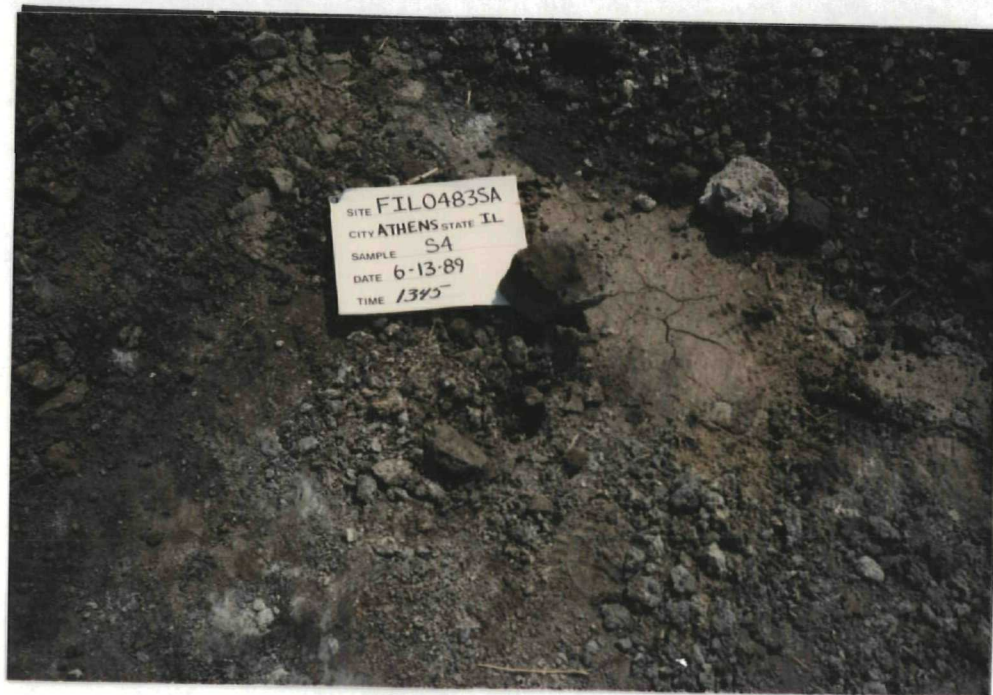
DESCRIPTION: close up of Soil sample S4.

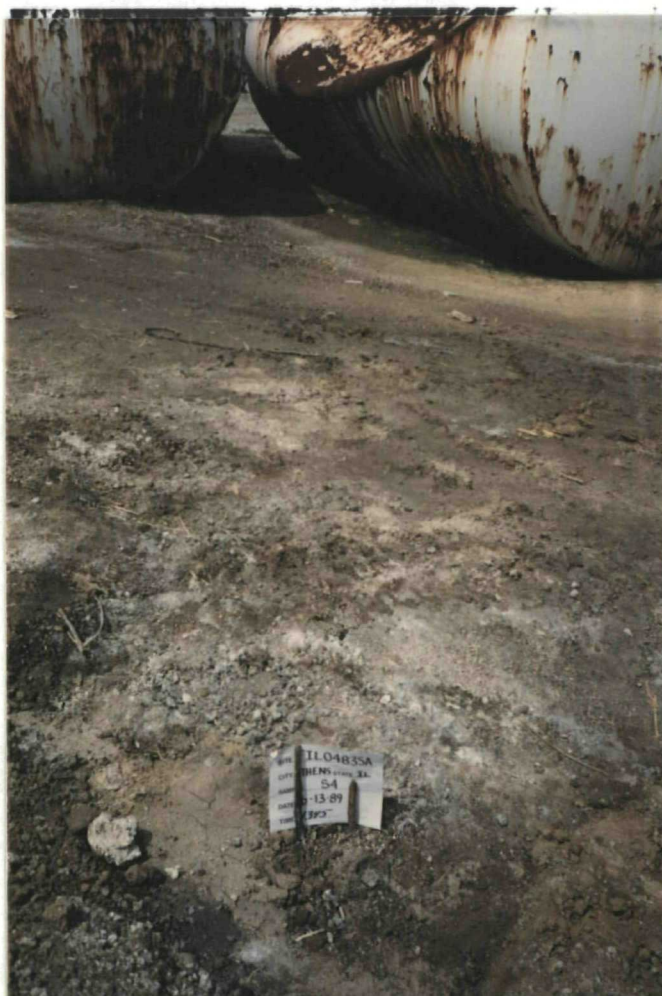
DESCRIPTION: is located near
the old storage tanks that
are no longer used. The
tanks are located at the
south east section of the
site.

In the southeast corner of the site, FIT observed several large, old, dented, and rusting storage tanks. One of the storage tanks had been burned. According to Ingram, the old rusting storage tanks will be crushed and buried on-site. Mapco does not have a permit for this disposal, and is not aware that one is needed. Next to one of the old storage tanks were several 55-gallon drums. The following labels were observed by FIT on some of the drums: Dow (serve 24) Nitrogen Stabilizer, and Flammable Liquid. FIT observed a 5-gallon can in one of the drums; the drum also had liquid in it.

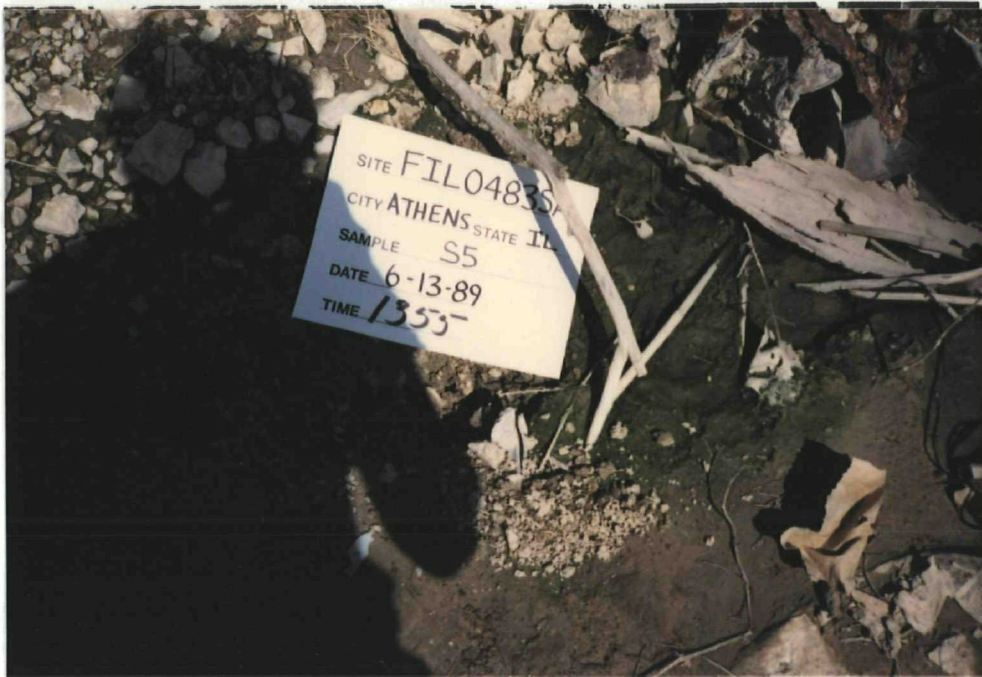
DESCRIPTION: Close up of S5

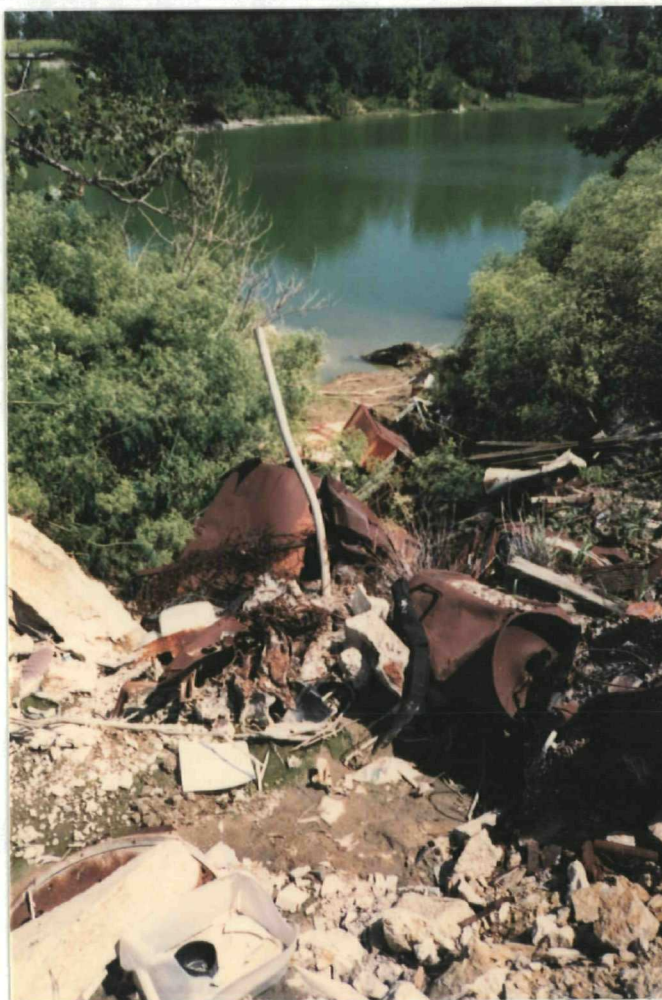
Approximately 7 feet south of the on-site lagoon was another refuse pile. The pile of refuse appeared to have been burned. Based on the presence of ash at the bottom of the pile and an odor of burnt refuse, FIT believes that the refuse pile had been burned. The ashes of the pile were gray. In addition, a red, powdery substance and green, flake-like substance were also observed at the bottom of the pile. The refuse observed in the pile included wood, washing machines, paint cans, drums, automobile batteries, a pressure tank, automobile parts, a refrigerator, and several water heaters. Ingram stated that to his knowledge the site has never been used as a dump.

DESCRIPTION: S5 was collected
near a pile of refuse that is
located south east of the onsite
lagoon.

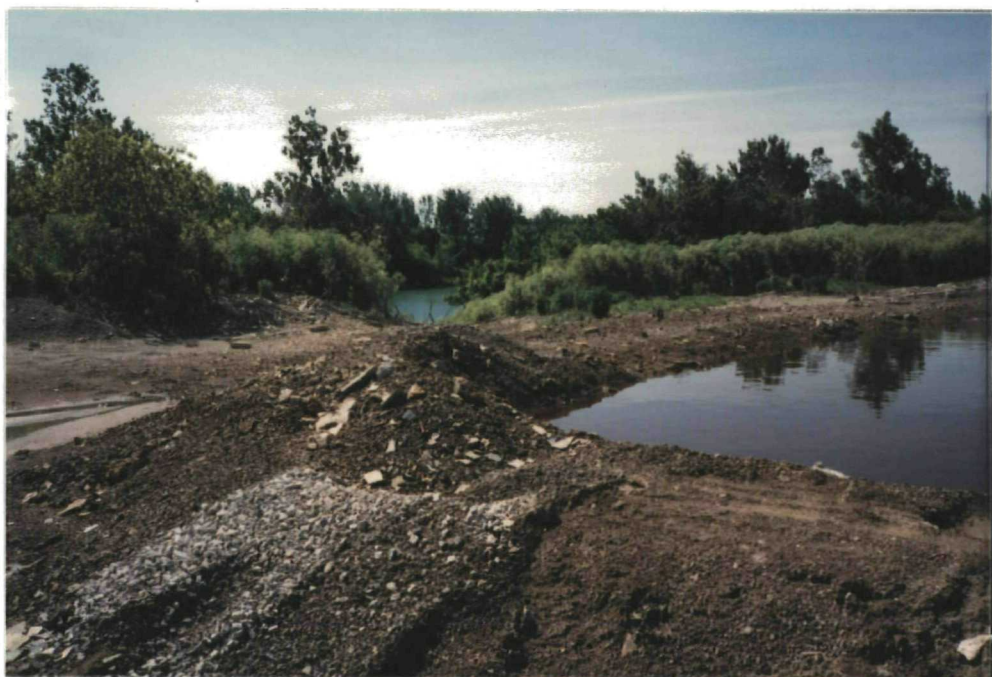
- FIT observed leachate from the on-site lagoon flowing down one of the on-site slopes that leads to the quarry lake.

DESCRIPTION: Photo of the on site lagoon and the quarry
is in the background.

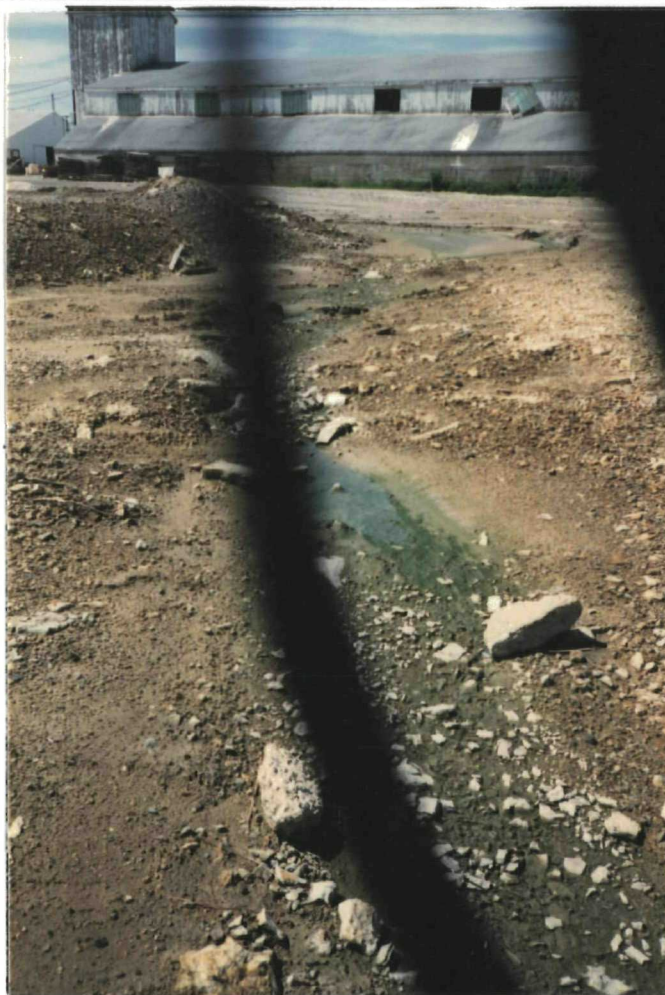
Approximately 10 feet to the north of the on-site lagoon, FIT observed water seeping out of the ground. Ingram indicated that a water pipeline drawing from the quarry lake had several leaks, and that the water seeping out of the ground was from the broken pipes. The water and the underlying ground were an algae-green color. FIT also observed a leachate stream emanating from the lagoon and flowing to the quarry lake from the pipeline. The leachate stream was flowing east to a terrace that slopes 35% to the east, into the quarry lake.

DESCRIPTION: The underground
water pipe from the quarry
had several leaks in it. Water
was notice leaking out of
the ground by F-I-T.

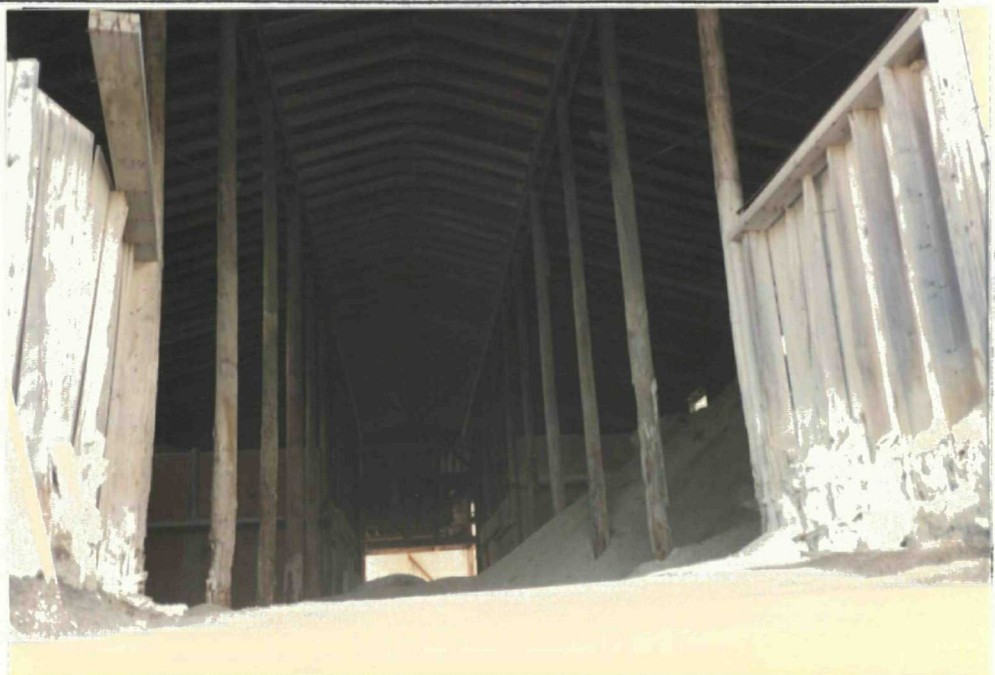
DESCRIPTION: The back entrance to the dry pesticide storage building. The building does not have doors.

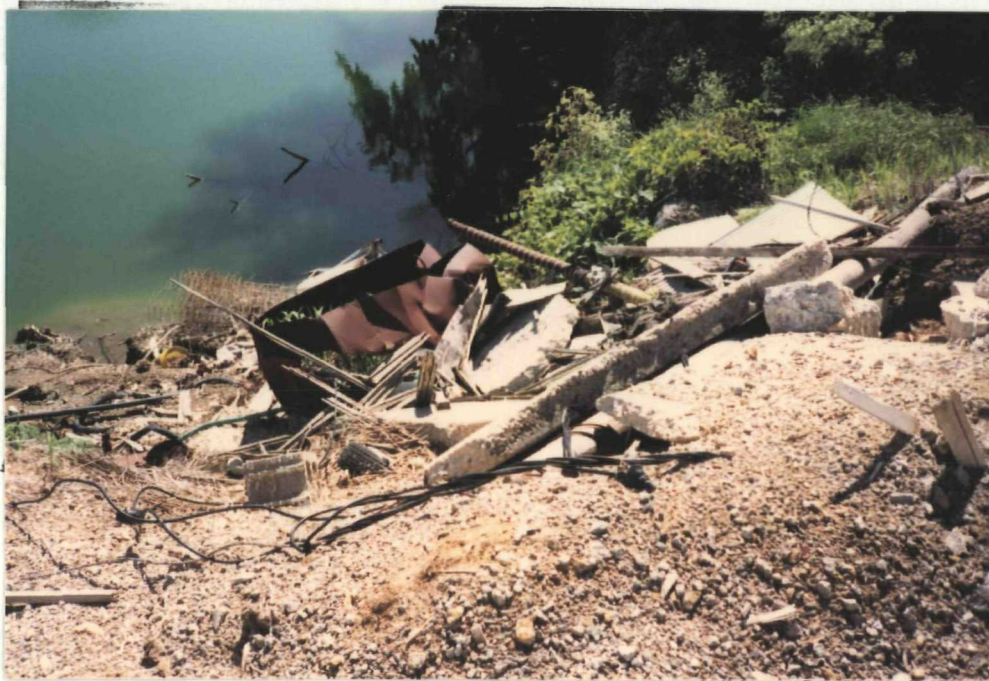
DESCRIPTION: Refuse located on the side of a slope behind
the dry pesticide storage building.

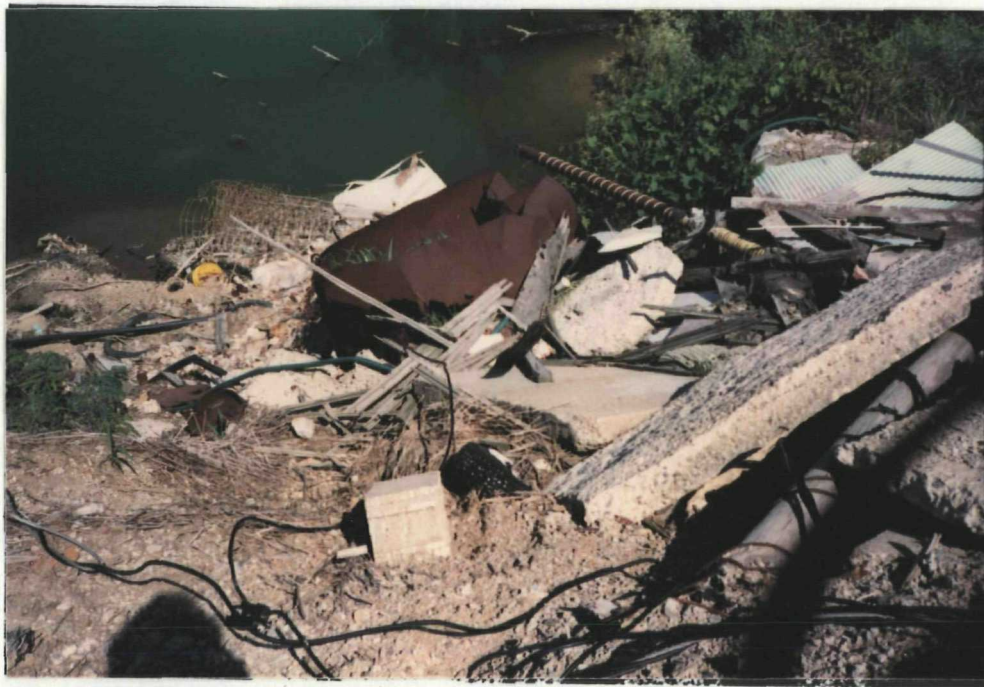
from the rear entrance to the warehouse. The channels are approximately 3 to 6 inches in depth and drain down the bank and into the quarry lake. Down the slope, FIT observed refuse that consisted of tires, pesticide bags, concrete pieces, a small rusty storage tank, and a storage tank that was partly submerged in the quarry lake.

DESCRIPTION: Refuse, tires, concrete pieces, wire, storage tanks, and
drums, are located on the side of a slope behind the dry pesticide
storage building. The quarry is a algae green color.

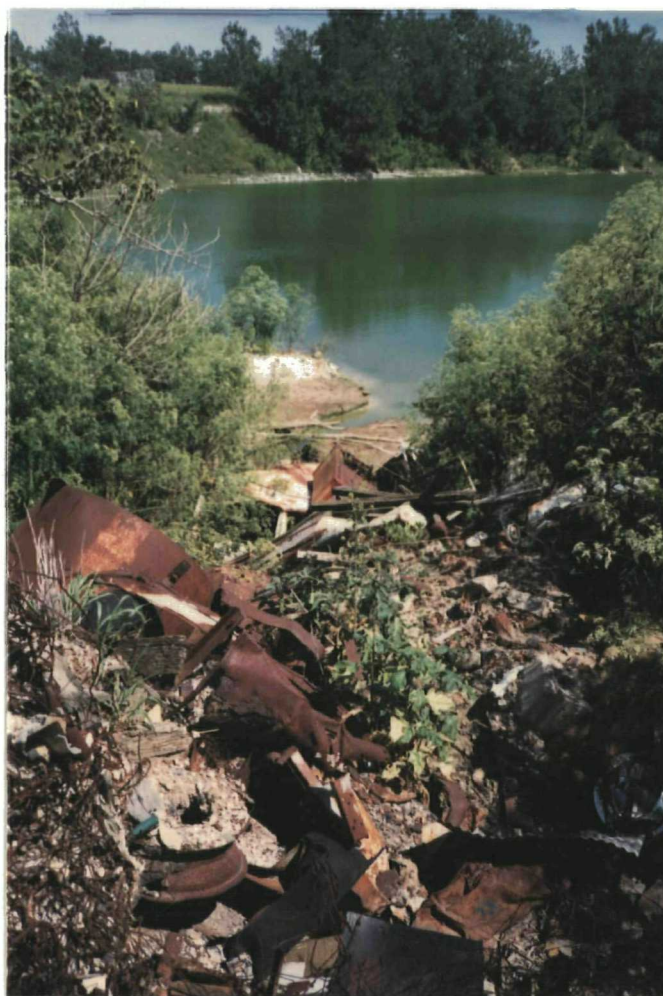
FIT observed refuse located on the terrace, including fence wire, bricks, tire rims, paint cans, storage tanks, drums, pesticide containers, automobile parts, and refrigerators. Most of the refuse was made of iron or steel and was rusting.

DESCRIPTION: tank, auto parts
wire, pesticide container,
and paint cans, located on
a slope east of the on-site
lagoon.

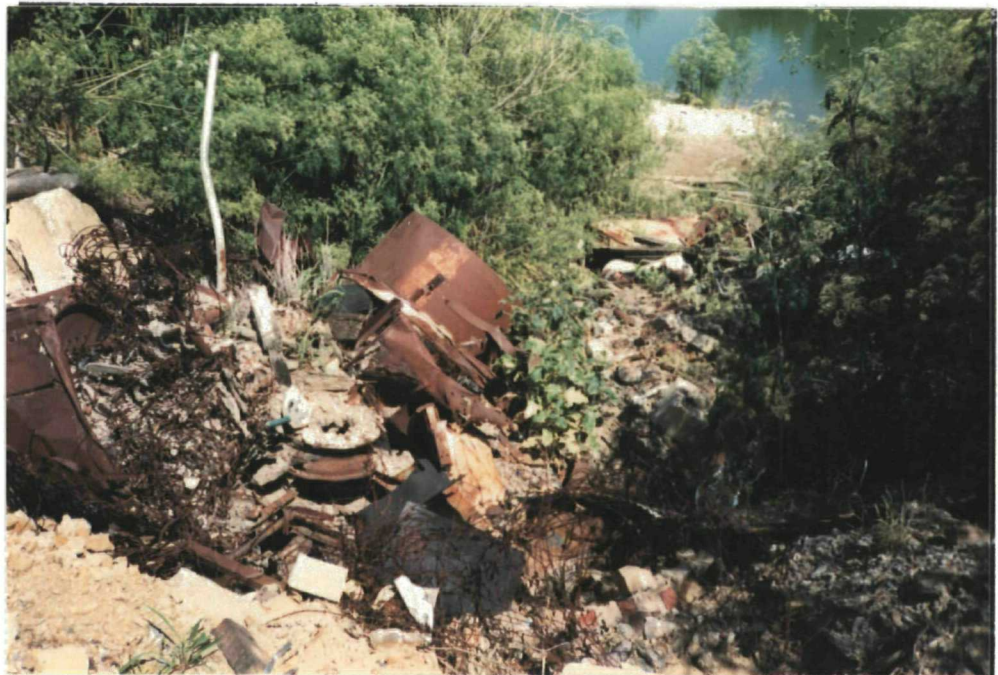
DESCRIPTION: Refuse locate on a slope, east of the on-site lagoon.

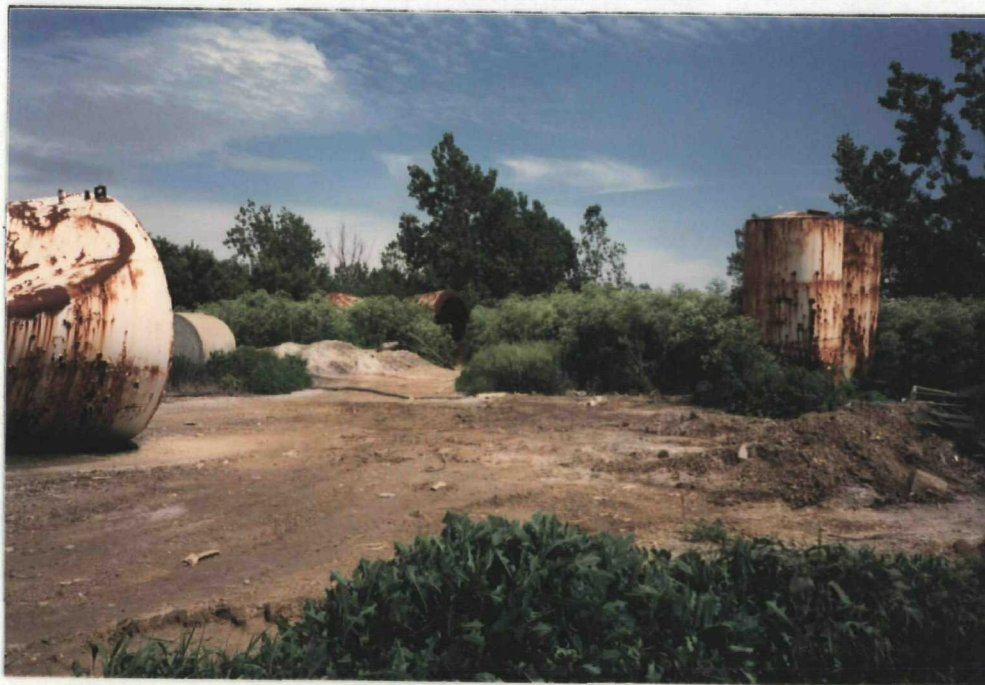
DIRECTION OF
PHOTOGRAPH:South-South EastWEATHER
CONDITIONS:SUNNY, 65° F.PHOTOGRAPHED BY:
RONNIE GALMORESAMPLE ID
(if applicable):
NADESCRIPTION: Old rusting storage tank. no longer used.

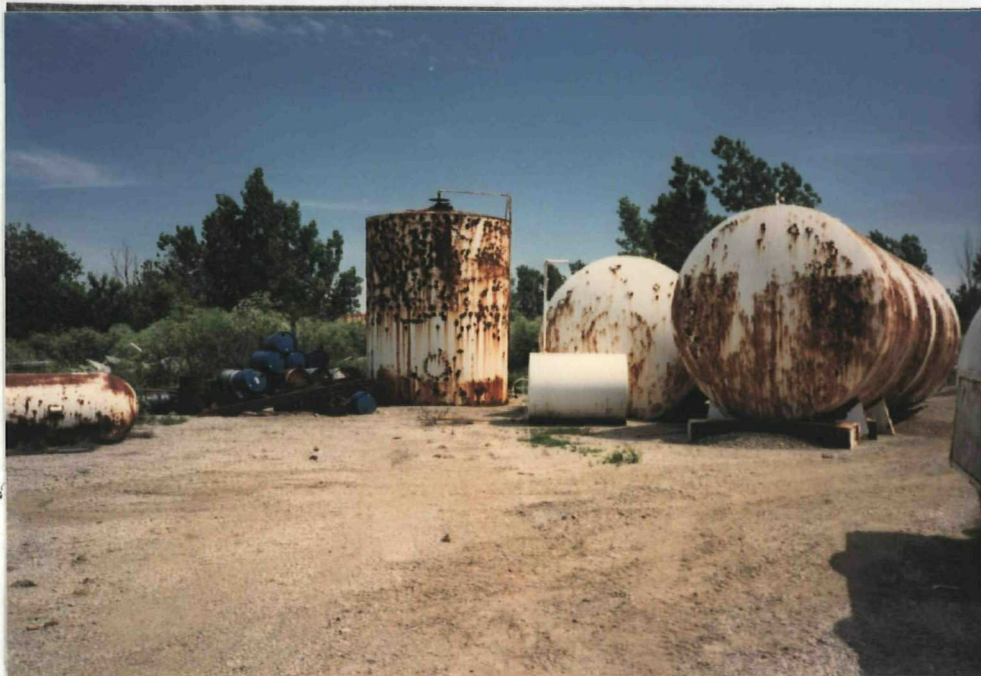
DESCRIPTION: Old storage tanks and 55 gallon drums.

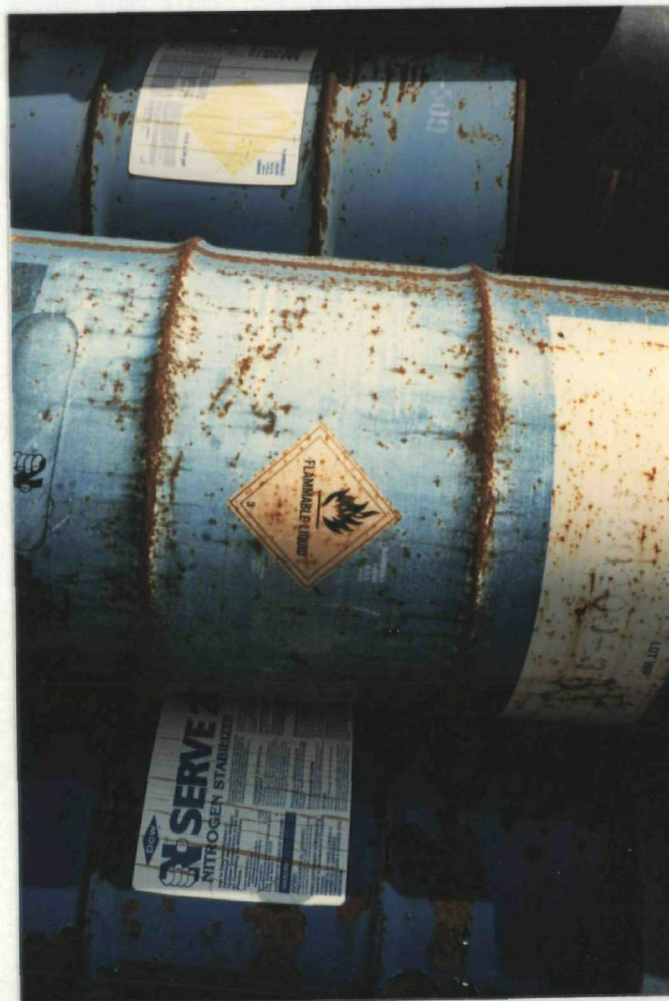
DESCRIPTION: next to the old
storage tanks. The labels on
the side of the drums read
"Flammable Liquid", "Dow
N Serve 24 - Nitrogen
stabilizer.

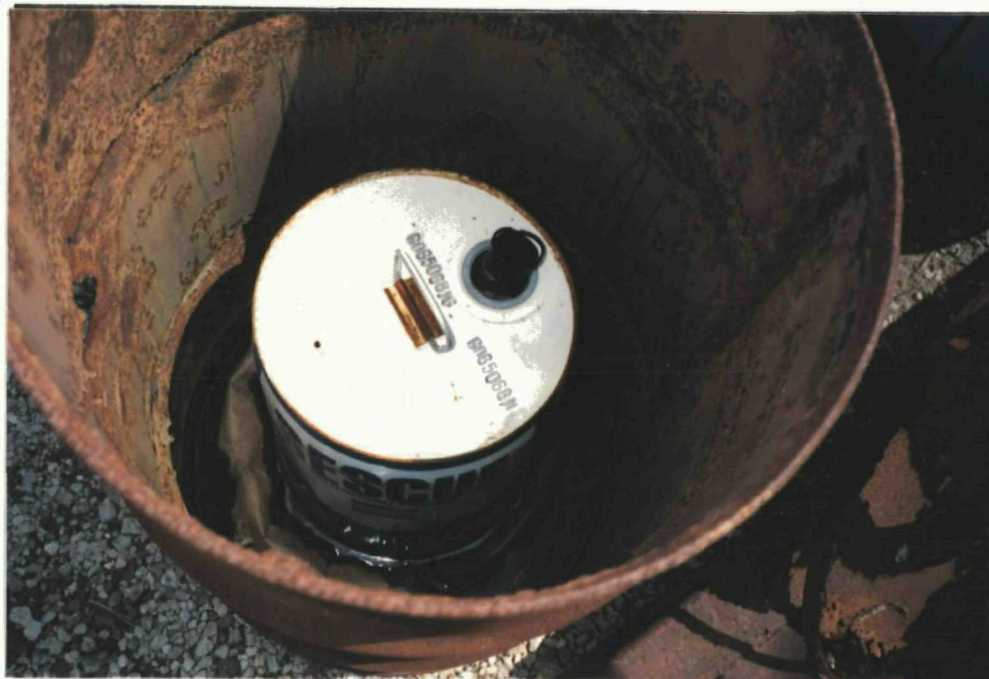
DESCRIPTION: A small 5gallon can inside a 55 gallon drum.

There was some type of liquid in the bottom of the drum, which is located next to the old storage tanks.

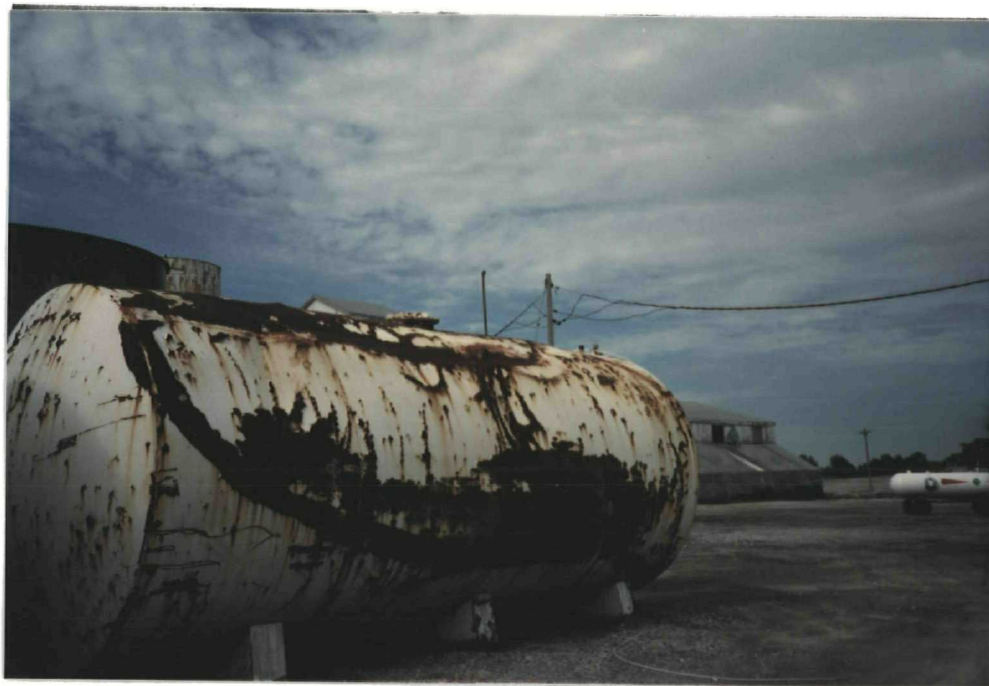
DESCRIPTION: An old rusting storage tank.

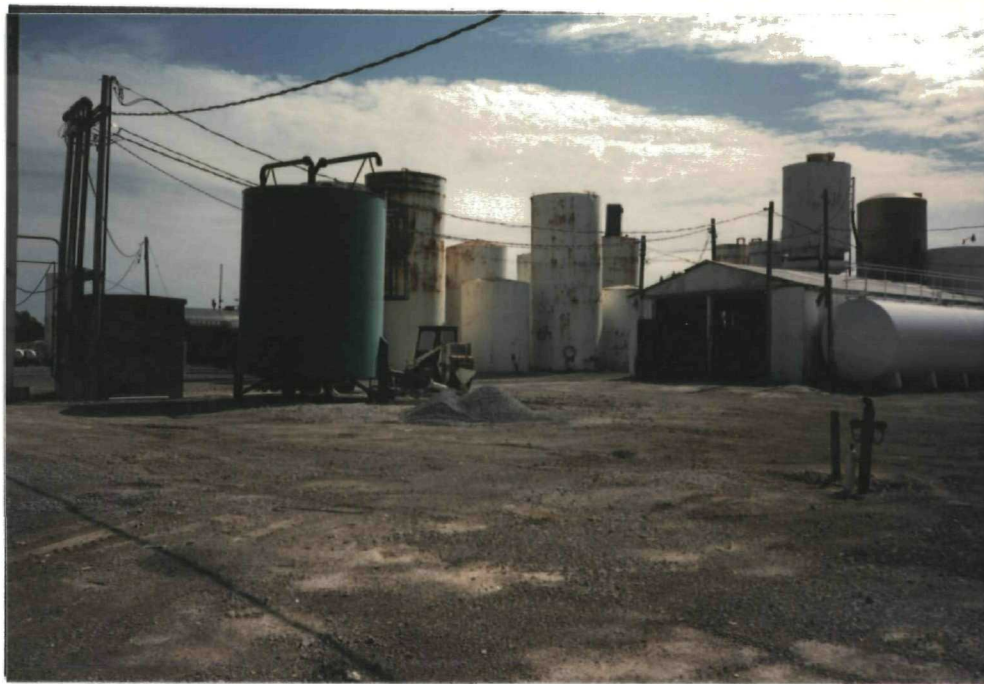
DESCRIPTION: A storage building and storage tanks located on-site, most of the storage tanks are rusting.

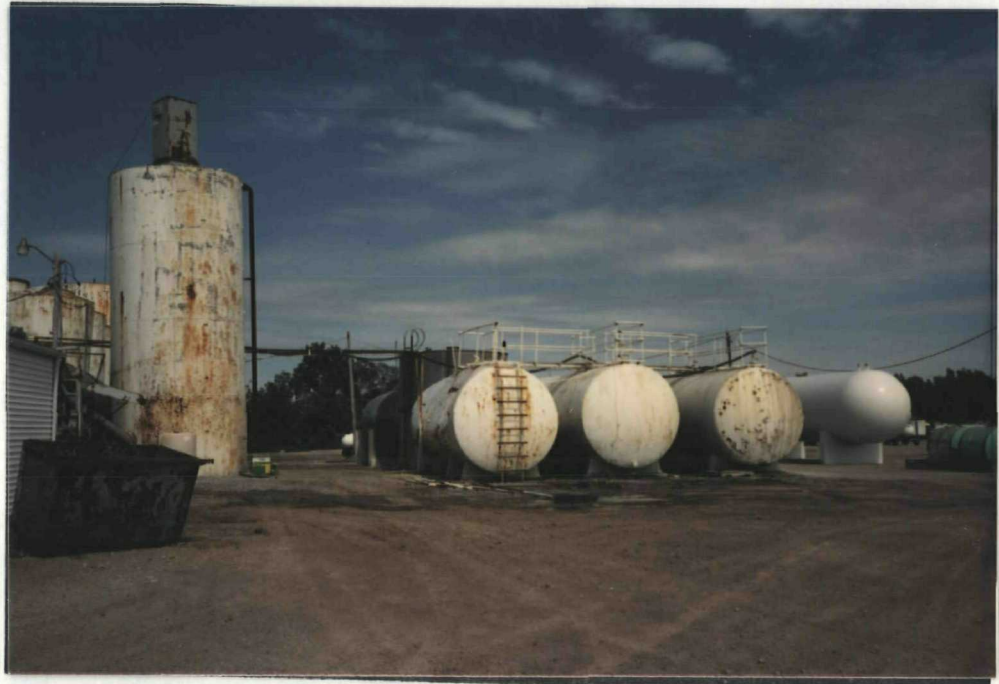
Located north of the small ammonia and propane tanks are the storage and mixing tanks that are currently used in facility operations. Most of the tanks are rusting and FIT observed that one of the tanks had a large dent in the side of it. FIT observed a Mapco employee open a valve on one of the storage/mixing tanks and let the liquid flow onto the ground until the flow stopped. The area around some of the active storage and mixing tanks was wet, and in some places liquid of an algae-green color with an ammonia-like odor was present. FIT observed that topsoil in areas surrounding some of the dry areas around the storage and mixing tanks was an orange and yellowish color.

DESCRIPTION: Large storage tanks. One of the storage tanks is dented.

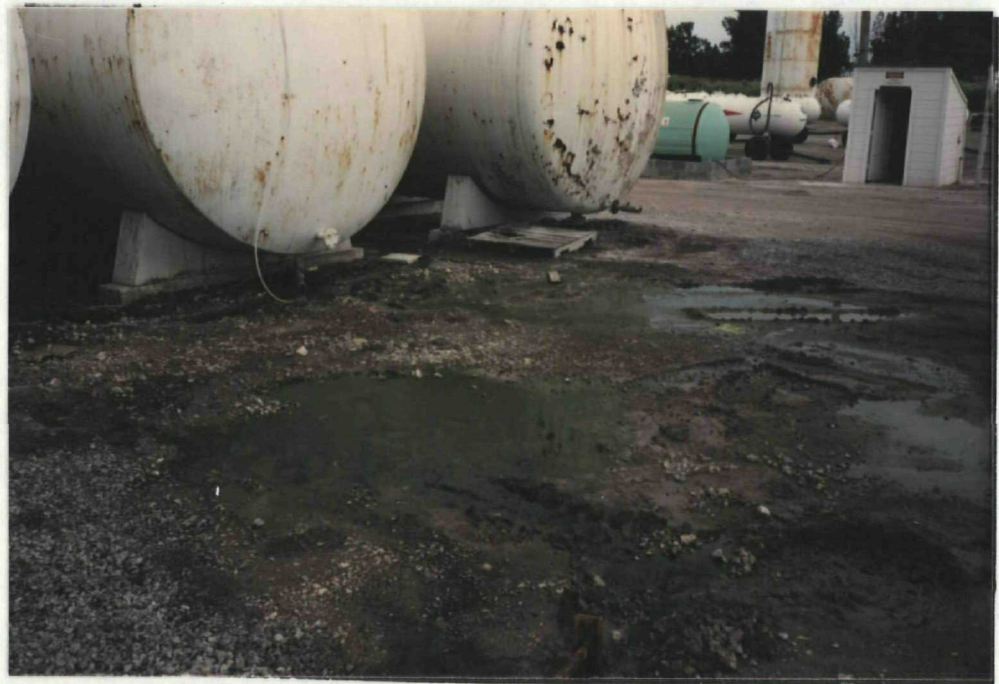
- The on-site lagoon is unlined (Ingram 1989).
- Waste in the lagoon is sometimes allowed to seep into the ground (Ingram 1989).
- Mixing water (water and product chemicals) from the storage/mixing tanks was observed by FIT to be leaking onto the ground.
- The site does not have a leachate collection system.

DESCRIPTION: Some of the storage tanks had discolored water around them.
